# Year End Water Quality Report

2104 Twin Creek Road  
Gibsons, BC

Year ending 2023

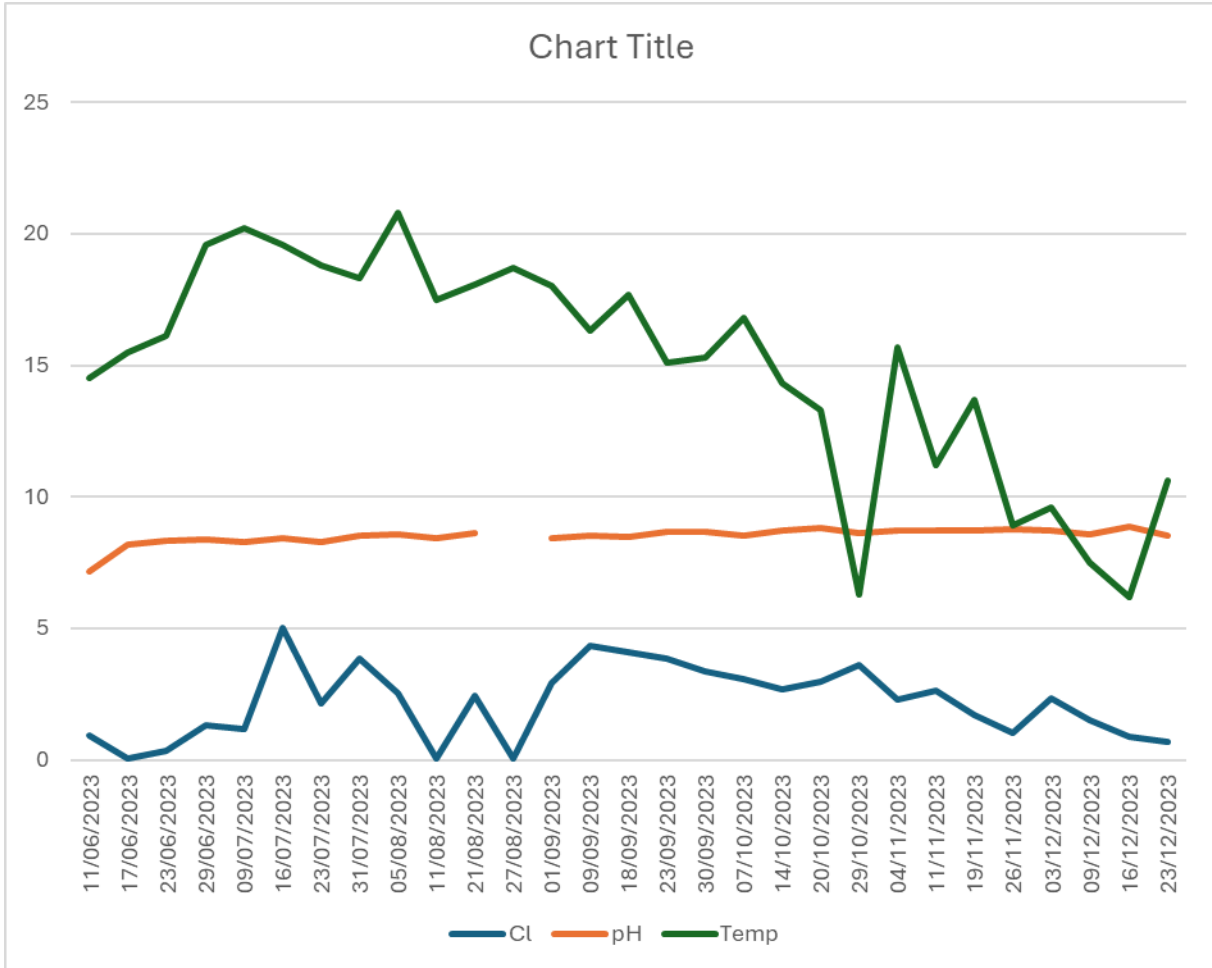
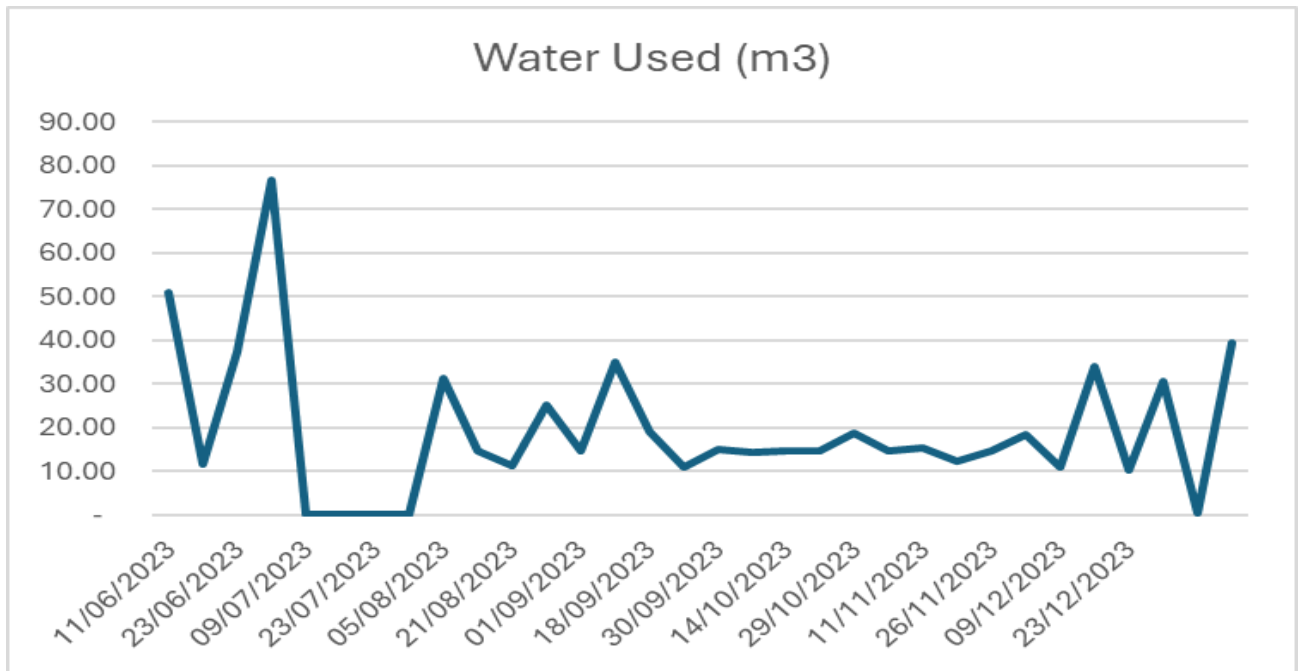
## Data Collected

Tests were conducted weekly at 2104 Twin Creek RV Park. The tests were done to monitor Cl concentration and pH. The Cl pump is controlled by the flow totalizer. Initially, this flow totalizer was installed underground. As a result, it was not functioning properly. For a while, the Cl pump was being turned on manually to maintain the proper Cl residual.
